CATES DAM

MONTGOMERY COUNTY, MISSOURI

MO. 10172

**PHASE 1 INSPECTION REPORT
NATIONAL DAM SAFETY PROGRAM.**

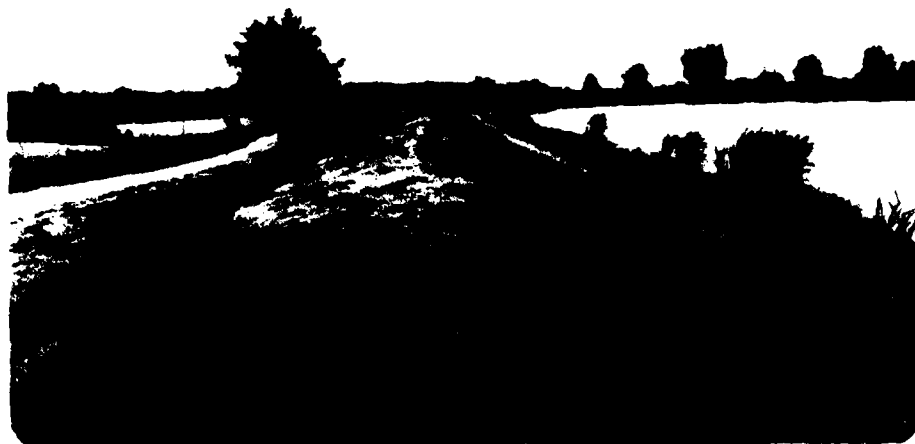
- (3) Crest. The crest is well vegetated with adapted grasses. A few small (1/8" wide x 2' long) cracks parallel with the axis of the dam were observed on both sides of the principal spillway. The cracks appear to be the result of desiccation. No rodent holes or deformations were noted on the crest. The crest and downstream slope had been recently mowed.

Drying cracks observed on the upstream berm and crest of the dam should not affect the stability of the dam.

PHOTO NO. 3 - CREST FROM LEFT END

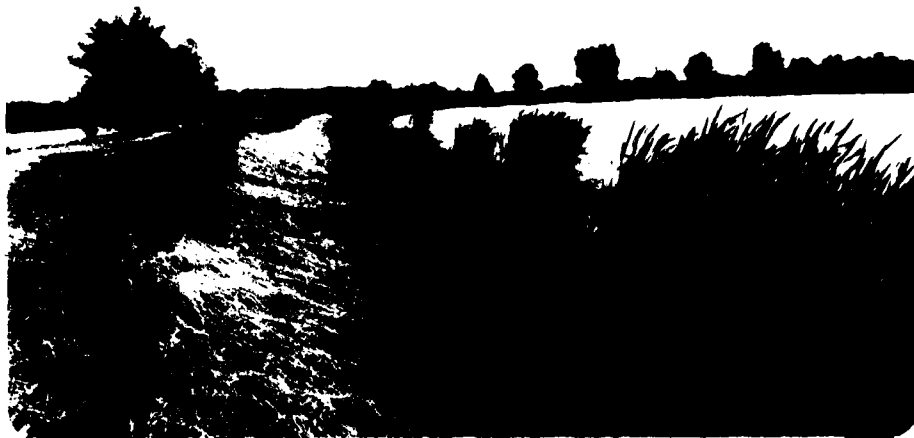
- (2) Upstream Slope. The upstream slope is well vegetated with adapted grasses and reeds. A few small willows are growing along the water line. There appears to be a berm at or near the principal spillway elevation. The water surface was just below the berm elevation when inspected. A few small (1/8" wide x 2' long) drying cracks were noted in the berm on both sides of the principal spillway inlet. No deformation was noted on the upstream slope. Some very minor erosion was noted toward the west (right) end of the dam at the junction of the berm and upstream slope.

Minor erosion on the upstream slope toward the right end of the dam could ultimately impair the integrity of the structure and should be corrected.

PHOTO NO. 4 - UPSTREAM SLOPE FROM LEFT END

- (2) Minor erosion on the upstream slope should be corrected.
- (3) A program of periodic inspection and maintenance should be initiated to control tree growth and erosion on the embankment and appurtenant channels.

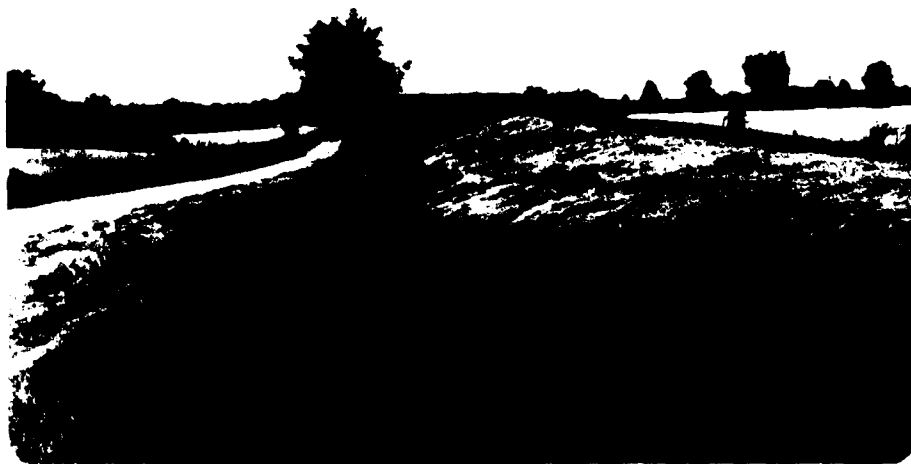
- (4) Downstream Slope. The downstream slope is very well vegetated with adapted grasses. No cracks, rodent holes or deformations were observed. There was no sign of seepage on the slope or along the toe of the dam.
- (5) Miscellaneous. The excellent vegetative cover and the apparent materials in the embankment indicate that this structure could withstand considerable overtopping without serious damage.

PHOTO NO. 5 - DOWNSTREAM SLOPE FROM LEFT END

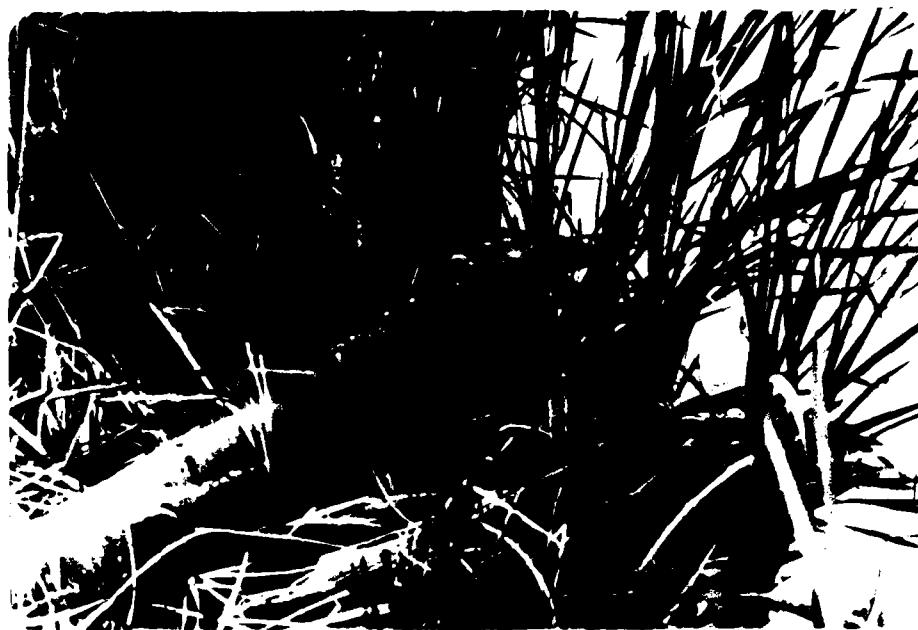
- (1) The principal spillway consists of a 10-inch steel pipe with hooded inlet and antivortex device. No deterioration of the pipe was observed. The inlet was clear and open. The reservoir level was about 1 foot below the inlet of the spillway.
- (2) The emergency spillway is cut through CL-CH soils on the right abutment. It is very well vegetated and open. No erosion, slump, slides or deformations were observed in the spillway. The exit channel for the spillway parallels the downstream slope of the dam but discharges should not cause any serious damage to the dam.

PHOTO NO. 6 - PRINCIPAL SPILLWAY INLET. HOODED INLET WITH
ANTI-VORTEX FLAP.

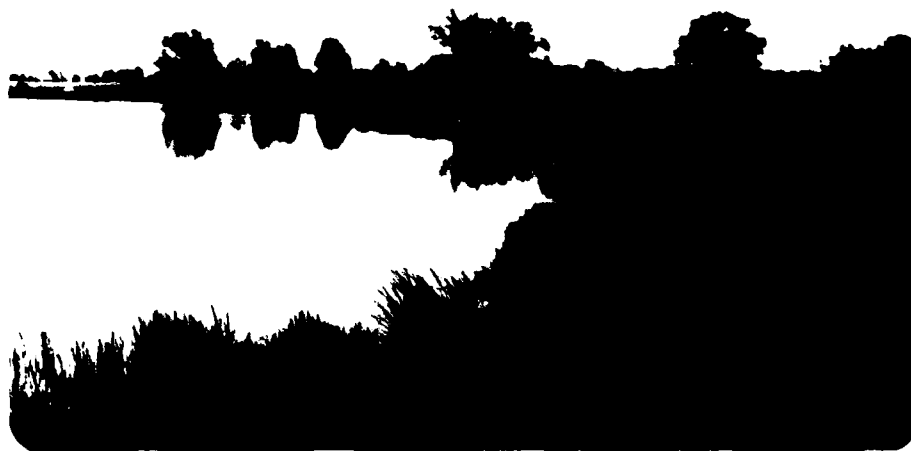
PHOTO NO. 7 - UPSTREAM SLOPE FROM RIGHT ABUTMENT.

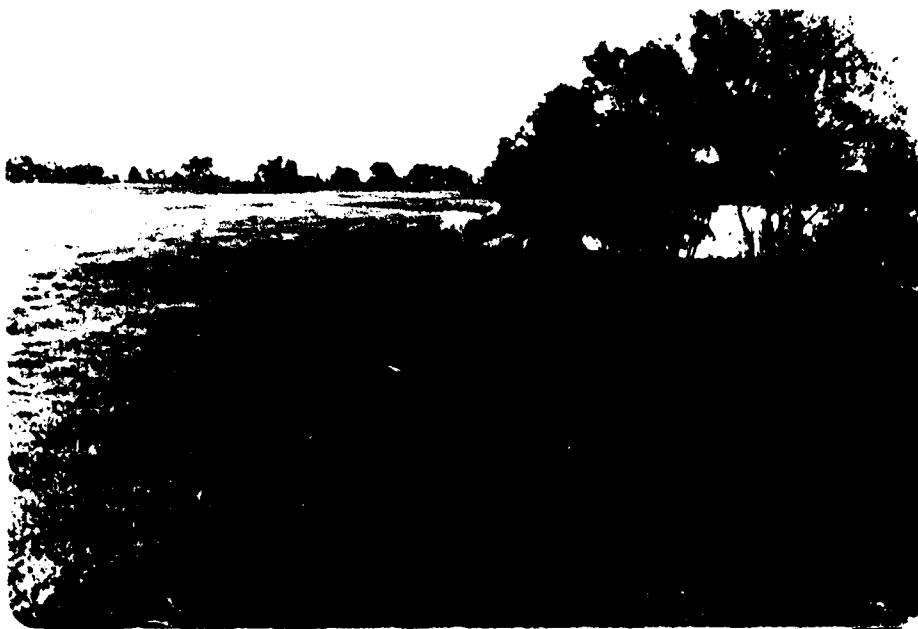
A few small trees are growing in the inlet to the spillway.

- c. Visual Observations.
 - (1) The principal spillway pipe appeared to be in good condition.
 - (2) The emergency spillway is located in the right abutment of the dam. A few small trees are located at the entrance of the spillway. Spillway releases flow along the downstream toe of the dam and into the old stream channel.

PHOTO NO. 8 - LOOKING UPSTREAM IN EMERGENCY SPILLWAY ON RIGHT
END

- a. Alternatives. Additional information should be obtained on the potential hazards of failure, and on the topographic characteristics of the reservoir area to determine the increase in the height of dam or the size of the spillway that is necessary to pass one-half the Probable Maximum Flood without overtopping the dam. The services of an engineer experienced in the design and construction of dams should be obtained to evaluate the present reservoir storage capacity, to provide seepage and stability analyses of the present dam, and to design protective measures, if required.
- b. O & M Procedures.
 - (1) Trees should be removed from the upstream face of the dam and from the emergency spillway inlet and outlet channel.

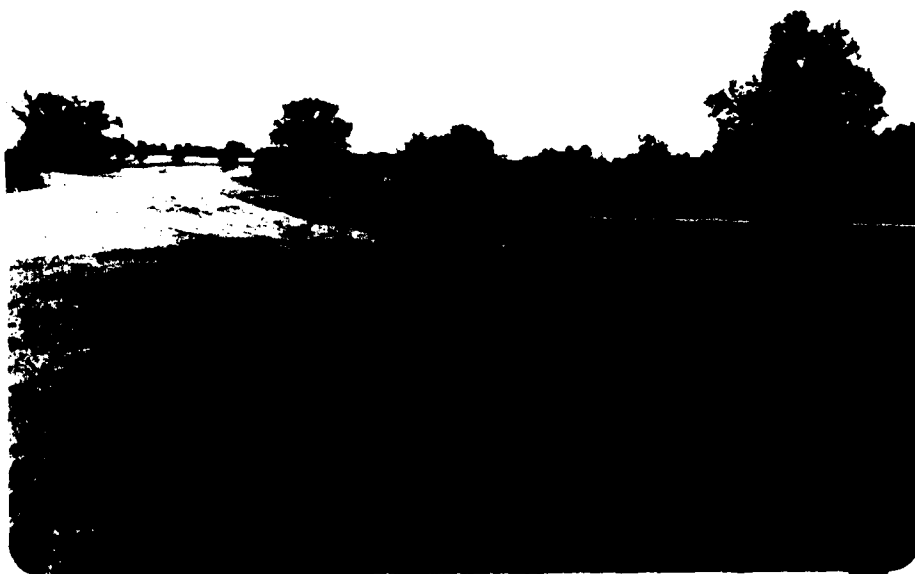
PHOTO NO. 9 - LOOKING DOWNSTREAM IN EMERGENCY SPILLWAY

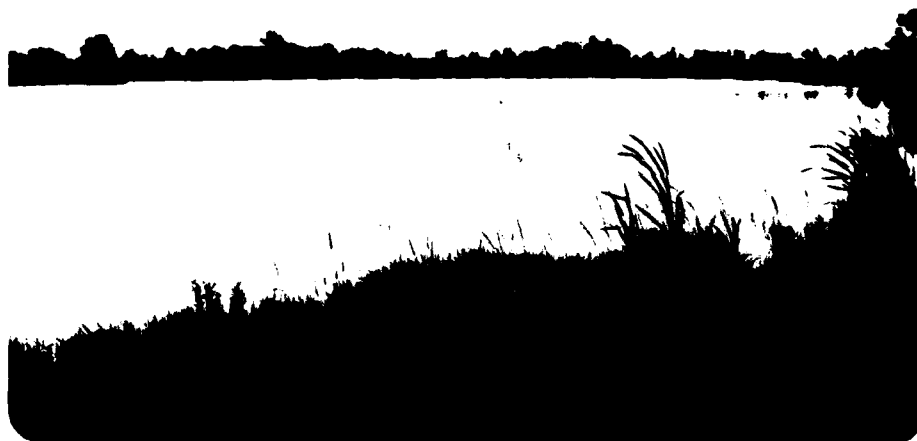
d. Reservoir Area. Some shoreline erosion was observed in the northeast corner and along the north shore of the reservoir. The erosion did not appear to be significant.

PHOTO NO. 10 - UPSTREAM ACROSS LAKE FROM RIGHT END
